St. Marys River
Shoreline Erosion and Shore Structure Damage
1980 Closed Navigation Season

February 1981

Corps of Engineers
U.S. Army Cold Regions Research and Engineering Laboratory
Hanover, New Hampshire 03755

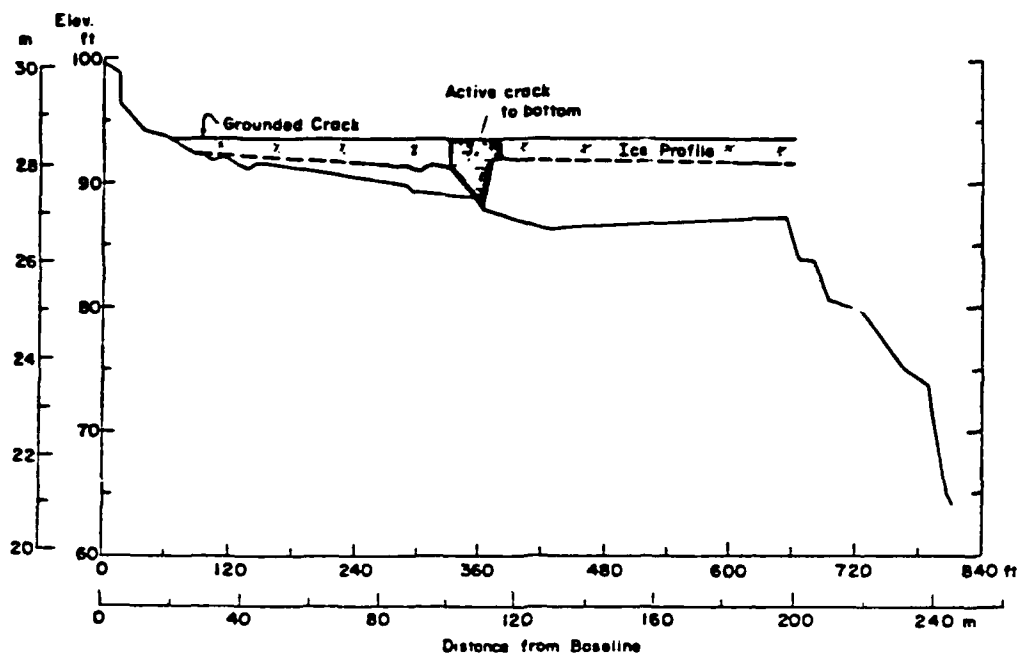
During winter ice conditions, the passage of the moving trough can cause the grounding of an ice cover in shallow water and nearshore areas, and nearshore cracks in the ice may develop running roughly parallel to the water depth contours. With recurring moderate water level fluctuations, these hinge cracks do not completely refreeze and can provide an ice-movement relief mechanism. Continuing vertical and horizontal movement of the ice cover may cause the accumulation of ice debris (which resembles pressure ridges) at these active cracks. Depending upon the characteristics of crack formation, ice dams extending to the river bed may develop at the cracks (Fig. 9).

Figure 9. Active crack profile.

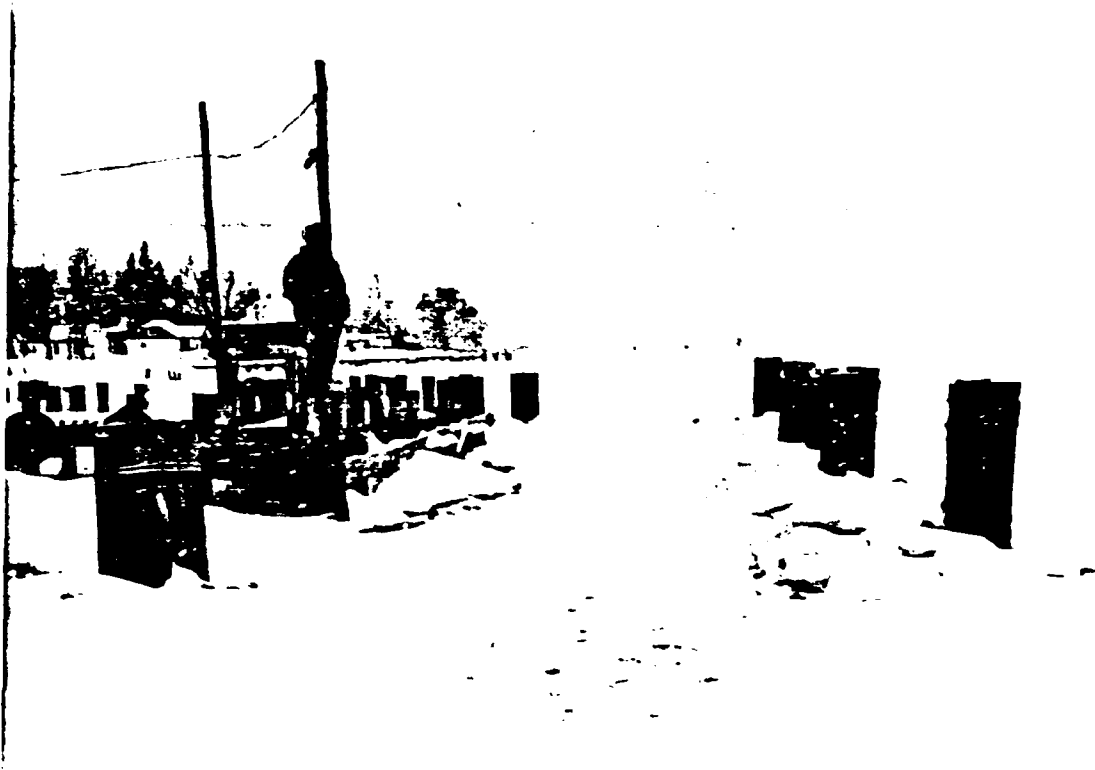
Figure 39. Dock at Six Mile Point.

with a series of eight finger piers extending from it parallel to the shore. This structure is then surrounded by 12 pile clusters as shown in Figure 39. This photograph is from a previous winter and shown the rubble piles which develop about the pile clusters during a period with navigation.

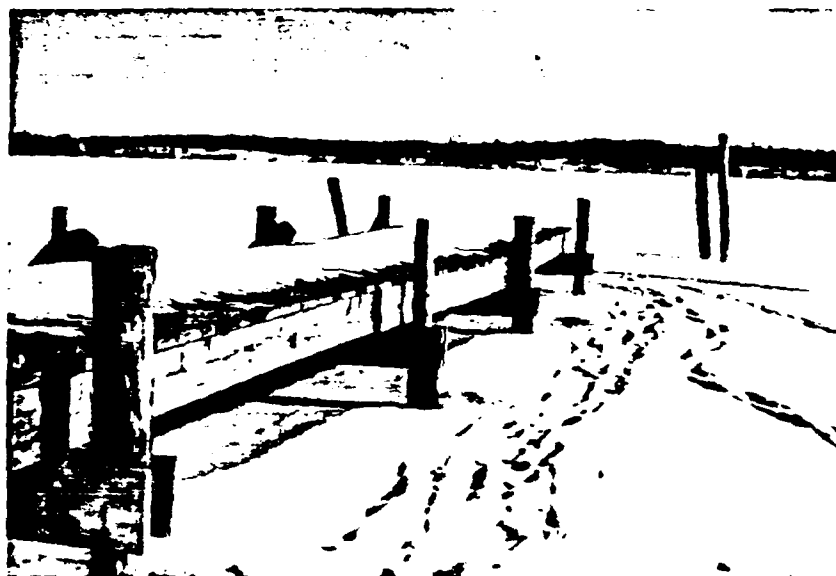
Prior to the 1978-79 winter navigation season, the Corps of Engineers had two demonstration docks installed at this site. One was a rock-filled timber crib as shown in Figures 47 and 48. The other shown in Figure 49 was a pile supported structure, with pile surfaces of various materials ranging from wood to plastic to steel. Both of these structures stood up

Figure 49. Dark Hole pile dock.

very well during both winters they were in place. The original Franklin Resort dock which can be seen on the left side of Figure 47 (9 February 1980) experienced no perceptible damage during the winter season.
